# MITSUBISHI MOTORS CORPORATION

## NEWS LETTER

| Model: <b>CK-6G7GDI</b> | Date: Jan. 18, 2002 | | | Nº: 02 - 008 | | |

Subject: **Repair procedure for poor acceleration, lack of power and low peak out**

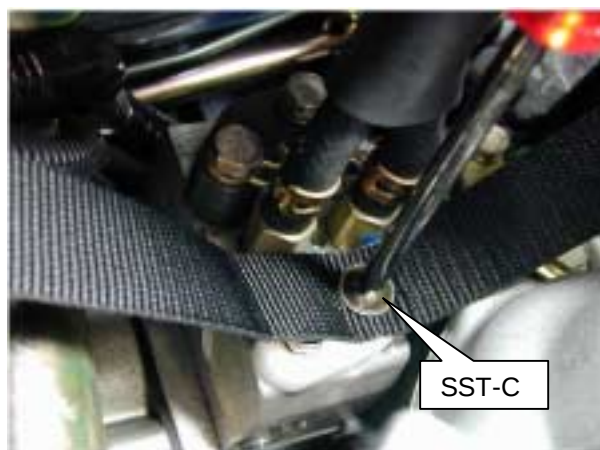
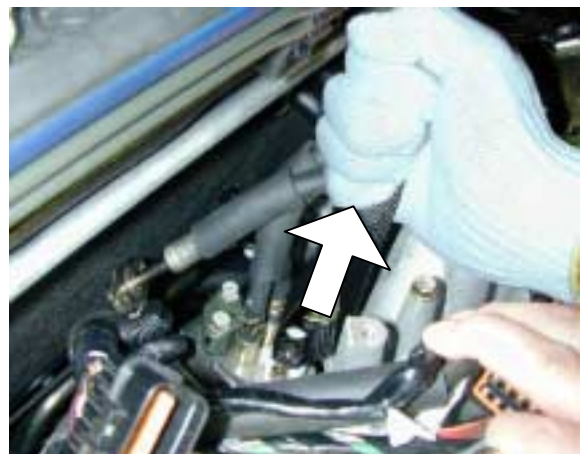
It is due to insufficient fuel flow caused by blocked filter in a high-pressure fuel pump. This filter is blocked by many foreign particles passing through a gap at a low-pressure fuel pump module second filter poor adhesion part.

7. Screw the SST-C in the guide hole **completely to the end**, and pull out the existing filter **at one go-off**.
