<h1>Product Report</h1>	Page : 1/3
Dealer: TWT East London	Author: Robert Raadgever Michelin Representative : Tim Viljoen	Reference : 2716 Date : 23/04/2012
End User: Marius Fourie	BFGoodrich : LT265/70R16 AT /TA KO 117/114S Original Tread Depth 12mm Dot: BE8D HX31 3010 (All 4 tyres same Dot)	Remaining Tread Depth Front Axle: 10mm Rear Axle : 9mm

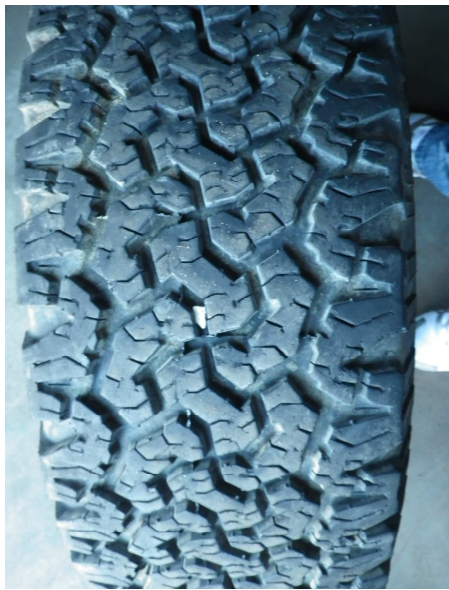
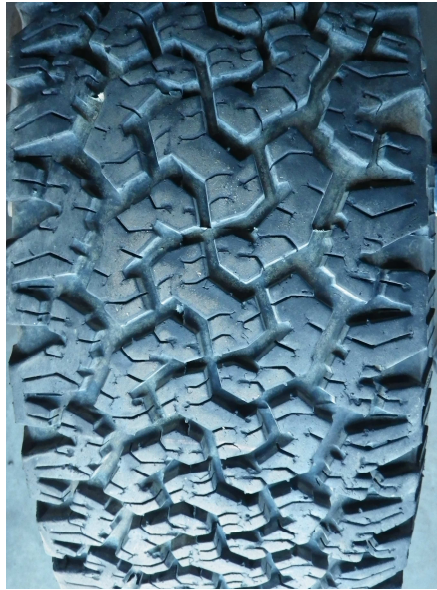
Rear Tyres (originally fitted to the front axle.)

The tread area showed signs of external aggressions across the whole tread with the aggressions been more pronounced on the shoulders,9mm of remaining tread depth. No signs of uneven wear were observed

Although the external aggressions are evident on the front tyres it must be remembered that the tyres had been rotated approxametly 2000Km's previously and that the aggressions originated on the rear axle of the vehicle

Over inflation leads to the increased possibility of tread chipping as the size of the tread contact patch of the tyre is reduced and the sidewall of the tyre's ability to flex and therefore maintain a stable tread contact patch is reduced.

- Lack of rotation
  - Rotate the tyres every 10 000 Km's. Front to Rear
- Pressures that exceed those of the vehicle manufacturer
  - Inflate the tyres to 2 Bar when cold. Cold pressures are when the vehicle has travelled less than 3 km's.
- Using the vehicle in 4x2 mode whilst travelling on gravel roads
  - Engage 4x4 when travelling on gravel roads to distribute the power to all 4 wheels

The tyres are safe for continued use and can be refitted to the vehicle for further use.

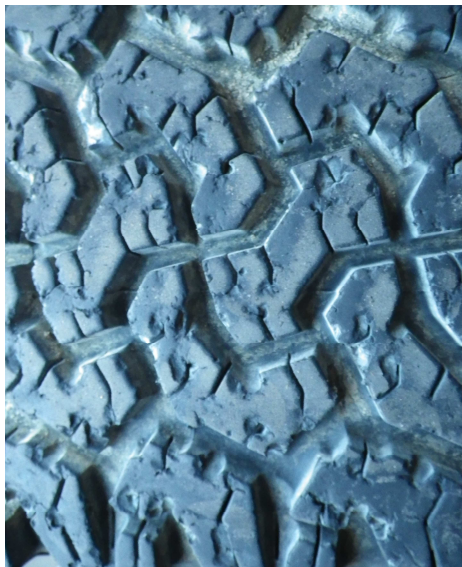
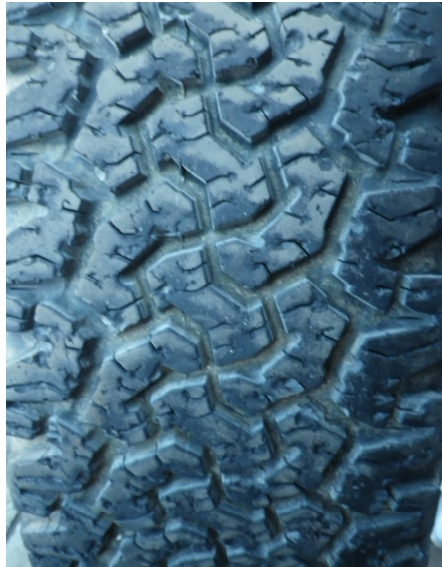
Front Tyres (originally fitted to the rear axle)

The tread area showed minimal signs of external aggressions,10mm of remaining tread depth. No signs of uneven wear were observed
