# ENIGMA AUTOMOTIVE FORENSIC SERVICES c.c.

## TECHNICAL INVESTIGATION REPORT: LJ04-0110

**Vehicle** : 2005 Mitsubishi Pajero 3.2 TD **Reg. No.:** VYR 050 GP

**Subject** : Condition assessment and engine damage analysis.

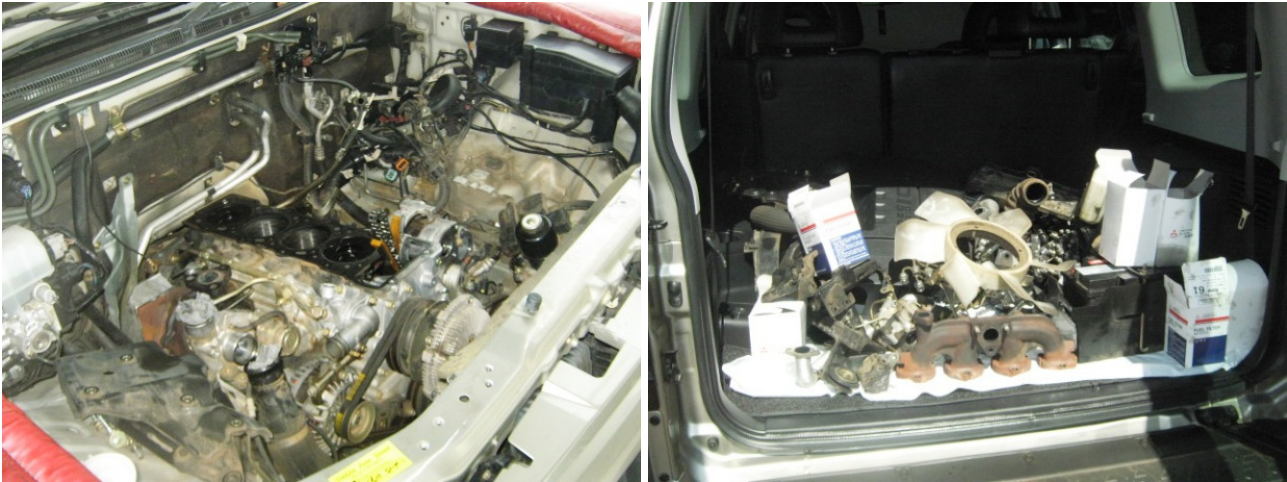
**Photo Plate 1:**

Examination of the engine in position in the engine compartment revealed the engine had indeed been stripped and the cylinder head and the associated covers and components had been extracted. (See photo plate 1).

Observe the stripped condition of the engine in position in the chassis. The displaced components were stowed in the rear of the vehicle.

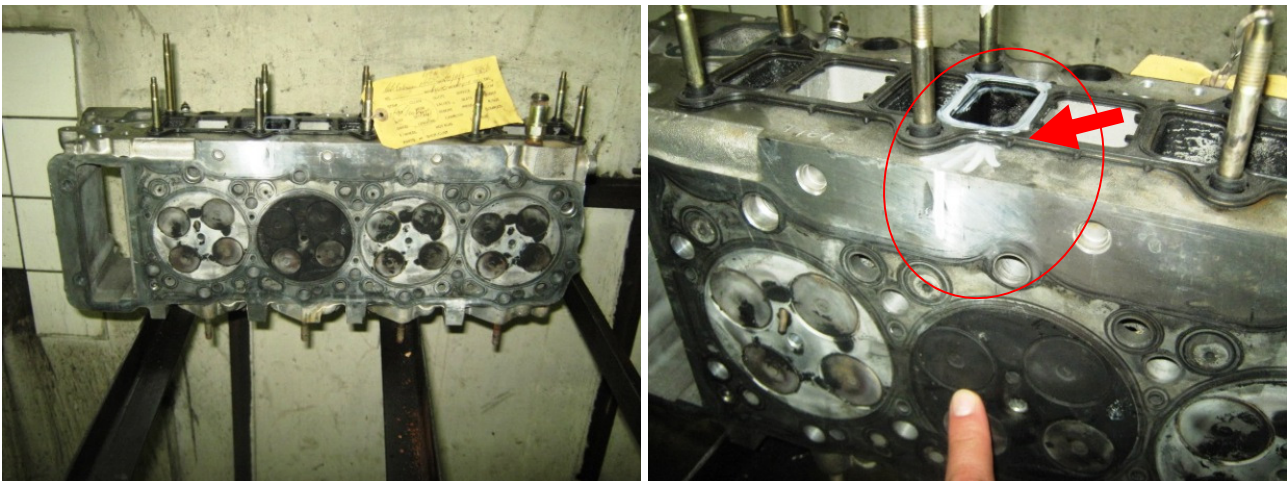
**Photo Plate 2:**

The cylinder head examined at the premises of Cylinder Head Services in Pretoria exhibited no evidence of any significant thermal discoloration on the cylinder head gasket's sealing deck. The cylinder head however is cracked in the port of the leading inlet valve in number two cylinder. (See photo plate 2).

The cylinder head was assessed for warpage and distortion with an engineer's straight edge and presented no evidence of any significant warpage. Some minor distortion was noted between cylinders two and three indicating slight yielding and most likely some movement of the cylinder head had occurred in-service. No evidence of any other visible structural damage or irregular conditions was noted.

A loss of coolant from the engines cooling system will result in further escalation of the temperature and this has resulted in the overheating condition that led to the cylinder head cracking in-service. Loss of coolant most likely provided space in the cooling system for steam to develop, hence the expulsion of coolant from the expansion bottle and the steam escaping from the cooling system when the condition was initially detected and the distress on the sealing elements of the thermostat.

Observe the condition of the cylinder head. Note the absence of any significant thermal discoloration on the gasket deck. In the right frame the red arrow indicates the pressure test result markings indicating leakage through the inlet port.

In closing the nature of the damage exhibited by this dictates the engine will have to be completely overhauled to restore the engine to a proper working condition. In the light of this it may be prudent to replace the engine’s sub-assembly and re-use the ancillary and bolt-on components. The latter would most likely be more cost effective.

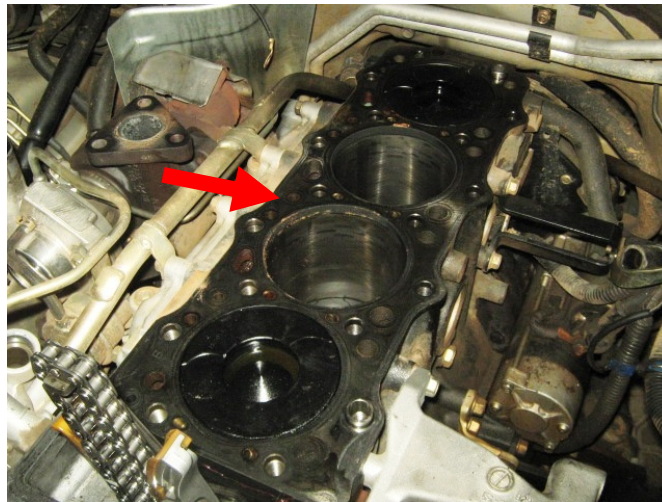
**Photo Plate 3:**

Examination of the engine block in position revealed evidence of some thermal discoloration on the gasket deck, specifically between cylinders two and three and around number four cylinder. (See photo plate 3). Evidence of water entry into the combustion chamber of these cylinders was noted in the form of rust oxide precipitation in the combustion chamber area. Evidence of some coolant seepage past the cylinder head gasket to the outside of the engine block was also noted. This is in the form of light staining of the surfaces of the engine block adjacent to the area where the cylinder head gasket has yielded.

These abnormally high combustion chamber temperature conditions resulted in the engine's cylinder head yielding slightly and the cylinder head gasket "blowing" through between the block and the engine and this condition resulted in a loss of coolant from the engine's cooling system. This is validated by the evidence of light staining on the side of the engine block.

Observe the thermal distress on the gasket deck of the engine block. Note the slight rust oxides forming in the cylinder bores.

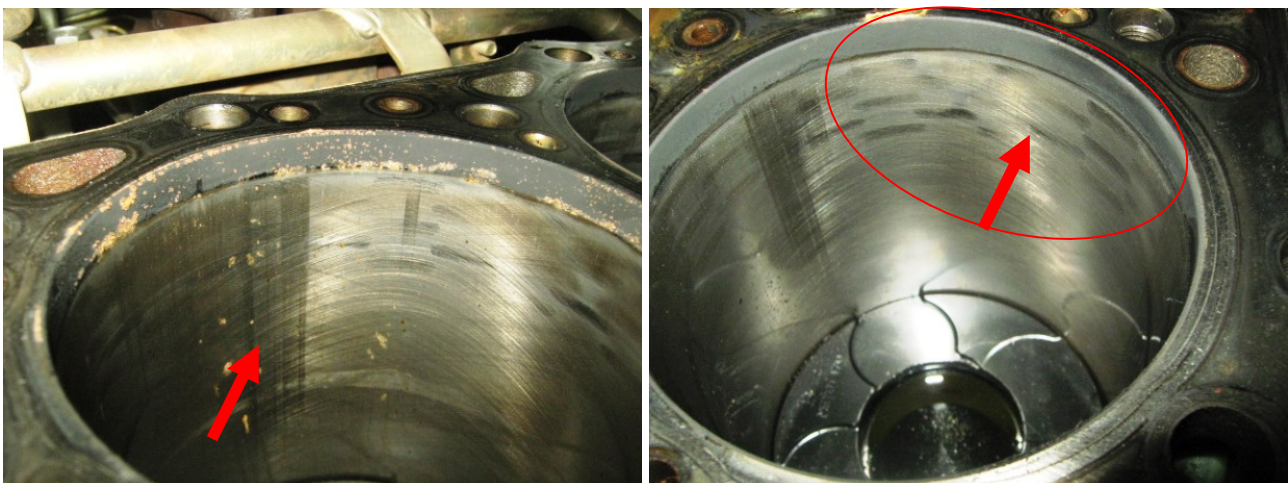
**Photo Plate 4:**

The cylinder bores all exhibit evidence of abnormally high combustion chamber temperature conditions having prevailed in this engine. This is in the form a "checker pattern" concentrated in the combustion chamber environment where a "heat soak" in the structure of the engine block has thermally discoloured as a result of significant heat dissipation through these surfaces. (See photo plate 4). The cylinder bores exhibit evidence of vertical piston to bore seizure damage commencing from the combustion chamber environment extending down the cylinder bores along the major thrust/ anti-thrust axis. (See photo plate 4).

The nature of the damage exhibited by this engine is consistent with a localised overheating condition concentrated exclusively in the upper cylinder bore and cylinder head environment of the engine. Evidence of significant heat saturation through the engine block indicates abnormally high combustion chamber temperature conditions occurred.

Observe the vertical piston to bore scuffing and seizure damage. Note also the characteristic "checker" pattern in the combustion chamber environment.

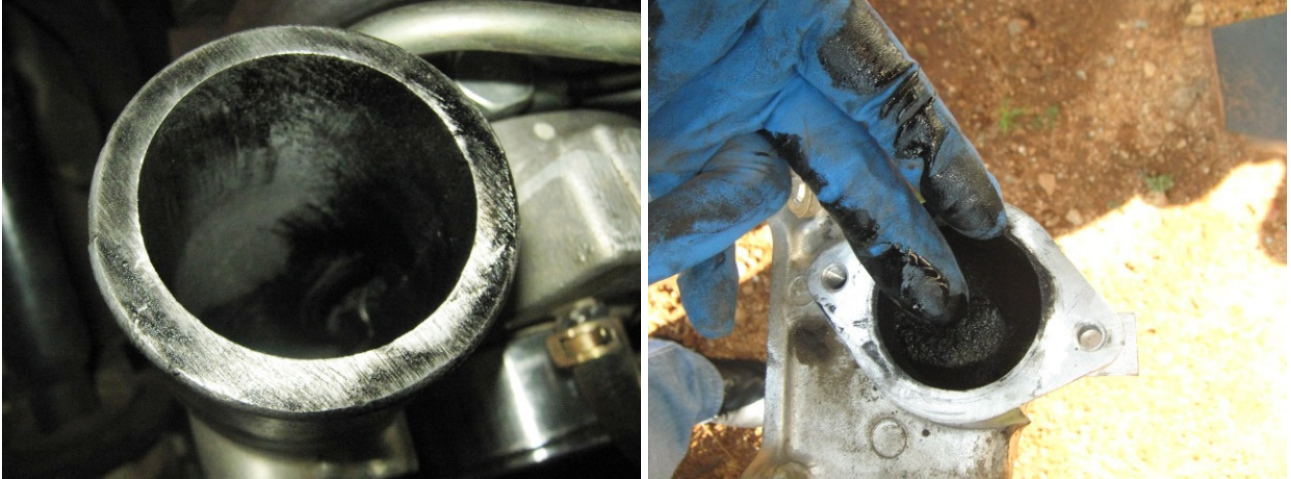
**Photo Plate 5:**

The turbocharger attached to the engine presents as normal with no indications of any visible damage to the impeller or deviation of the turbine shaft. Some oil saturation in the compressor side of the turbocharger and in the engine's intake manifold was noted. (See photo plate 5). Examination of the turbocharger's intercooler pipes revealed evidence of similar oil saturation in the pipes between the turbocharger and the air filter housing however, the section of the air induction pipe between air filter housing and the junction of the breather pipe recycling gasses from the engine's breather system in the tappet cover into the air induction system is dry, while the section of the pipe beyond the breather pipe junction is saturated with oil. The turbocharger intercooler does exhibit some evidence of oil saturation around the intake and delivery ports of the heat exchanger. No evidence of any damage to the intercooler core was noted.

The abnormal high combustion chamber conditions had more than likely derived from the introduction of engine oil and oil vapour into the combustion chamber environment of the engine. This oil will have gained access into the engine's combustion chambers via the air induction system and this is evident through the oil saturation condition found in the turbocharger's air induction pipes between the junction of the positive crankcase ventilation pipe, the turbocharger and the throttle body.

The root cause of the damage in this engine lies in the introduction of engine oil and oil vapour into the air induction system and this condition most likely derived from increased engine "breathing" conditions. "Breathing" occurs when compression pressure and combustion gas bypasses the pistons and rings and upon reaching the crankcase begins to pressurise the crankcase. This condition will result in oil being pushed up into the tappet cover environment where it is vented from the engine via the positive crankcase ventilation valve and re-introduced into the engine via the air induction system.

Observe the oil in the engine's air induction system manifold and turbocharger compressor side.

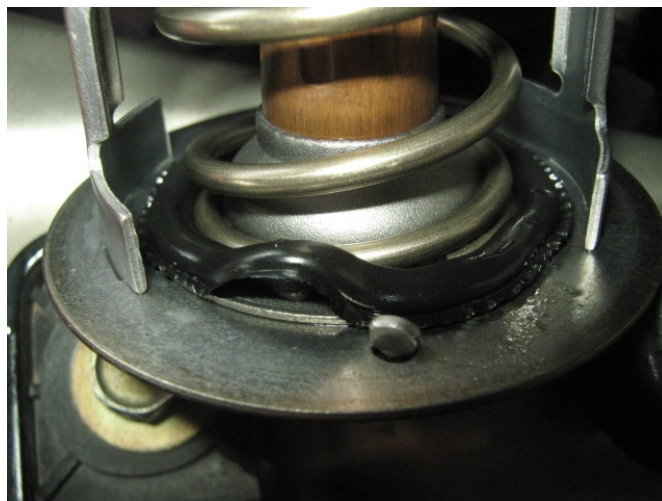
**Photo Plate 6:**

The thermostat housing was removed to expose the thermostat unit and inspection thereof revealed evidence of distress on the rubber sealing elements deriving from steam impinging on the rubber material. (See photo plate 6).

Observe the distress on the rubber sealing elements of the engine's cooling system thermostat.
