Make	MITSUBISHI
Series	PAJERO
Reg. No.	YFW679GP
VIN No.	AFADGBP46DR293316

technical examination™

DATE: 22.09.2010

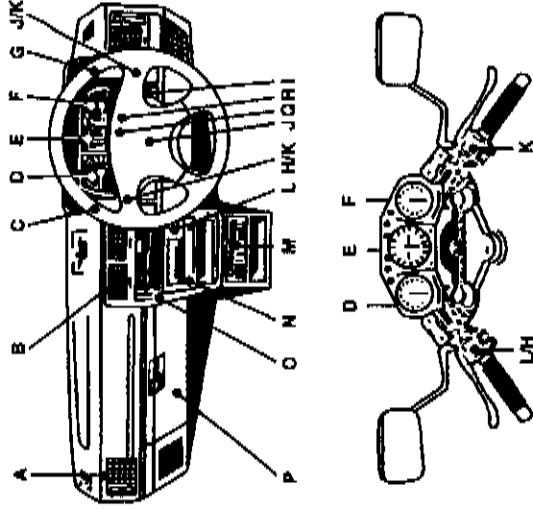
11 INSTRUMENTATION

A	Air vents	✓
B	Centre air vents	✓
C	Steering wheel	✓
D	Speedometer	●
E	Fuel gauge	✓
F	Rev counter	●
G	Wiper switch	✓
H	Headlight switch	●
I	Cruise control switch	✓
J	Hooter	●
K	Indicator switch	●
L	Cigarette lighter	✓
M	Radio	✓
N	Ashtray	✓
O	Heater controls	✓
P	Glove compartment	✓
Q	Heat gauge	✓
R	Oil gauge - light	●

7.1 NOISE IN CLUTCH/INPUT SHAFT
 7.2 DRIVE LINE VIBRATION
 TUNE ENGINE
